Effect of Installation of Oxidized Slag Boulders on Aquatic Habitat in Artificial Channel

Youichi Yasuda¹, Yoshinori Masaki², Tsutomu Wakana³, Ken Kato³ & Katsushi Maeda⁴

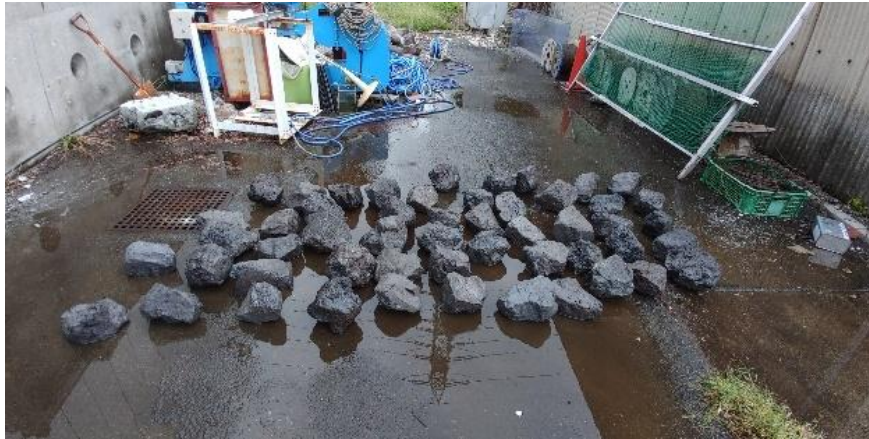
Photo 1. Oxidized Slag Boulders (tested 52 boulders)

To prevent the painted metal base from affecting the observation of aquatic organisms' behavior within the stone structures, small pebbles (average size 0.53 cm) over a 4.5 m section and crushed stones (average size 1.6 cm) over a 0.45 m downstream section, both approximately 5 cm thick were installed. The stone structures were then placed on top of these layers. Further, stones averaging 9.2 cm in size were installed at the downstream section 0.3 m. Here, average size is defined as the meaning of the long side, short side, and height. Fifty-two pieces of oxidized slag produced at the Chita Plant of Daido Steel Co., Ltd. were used (see Photo 1). The installation status of the slag and natural boulder is shown in Photo 2.

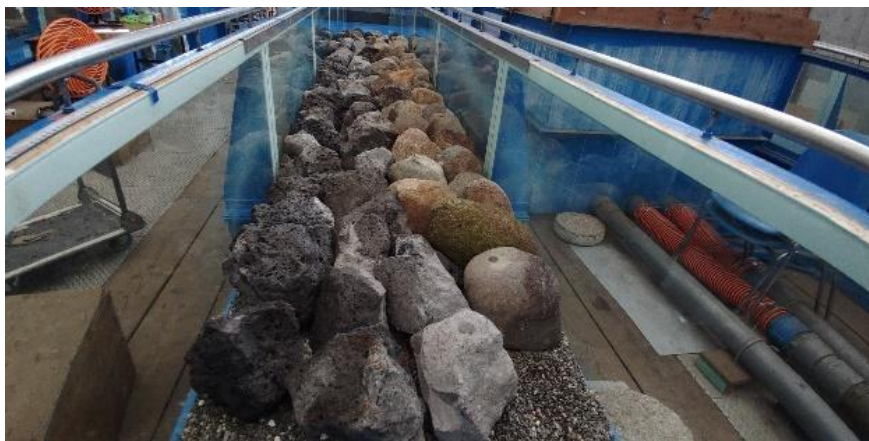
Photo 2. Installation of assembled boulders (left side Slag)

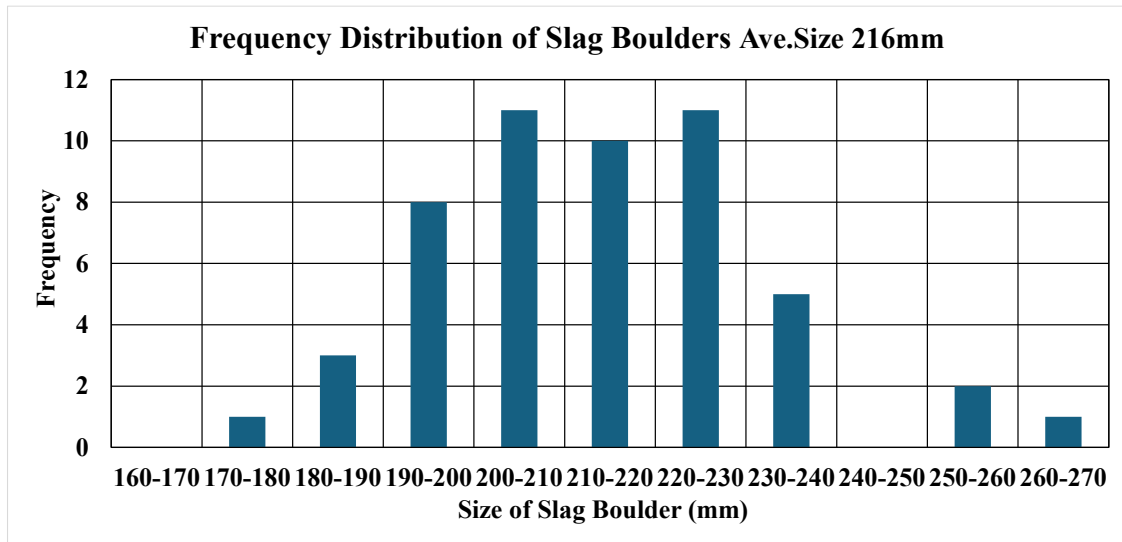
Figure 1. Frequency distribution of size in oxidized slag boulders

The frequency distribution by size for the oxidized slags and natural stones is shown in Figures 1 and 2, respectively. The average size of the oxidized slag was 0.213 m. The natural boulders were gravel from Gunma Prefecture, with an average size of 0.206 m. To account for aquatic animals' utilization of flow through gaps, the consecutively assembled boulders were installed as approximately four rows of stone placement. Experiments were conducted in September and November. In September, oxidized slag was placed on the left side and natural stones on the right side. In November, natural boulder was placed on the left side and oxidized slag on the right side. This arrangement was made because a pathway runs alongside the channel on the left side in the flow direction. It was done to prevent any misinterpretation regarding the swimming behavior in the oxidized slag placement area and the use of the flow inside slag gaps, which could result from the avoidance behavior of aquatic animals introduced into the channel. In addition, the porosity ratio of both the natural boulder and the oxidized slag is approximately 46%.

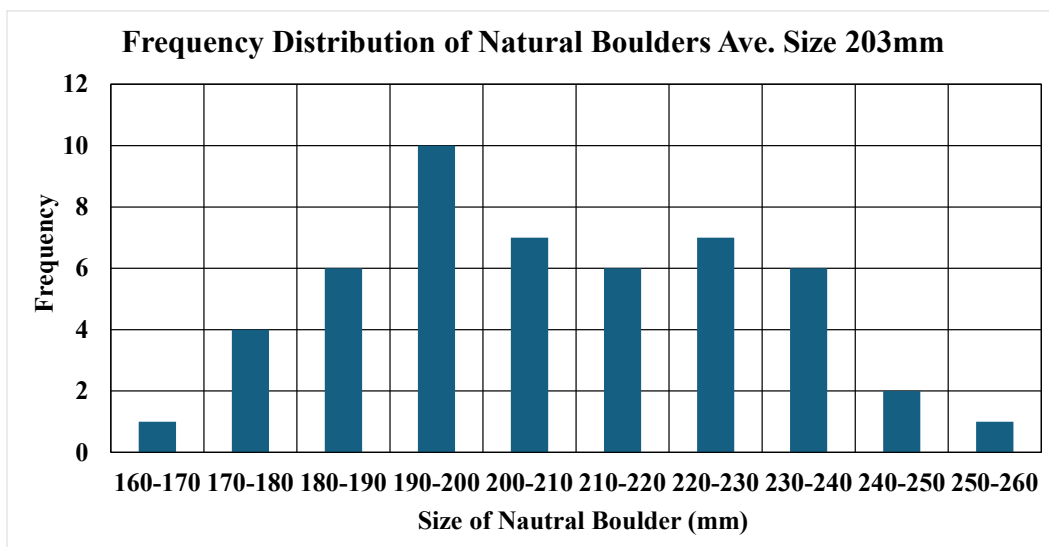
Figure 2. Frequency distribution of size in natural stone boulders

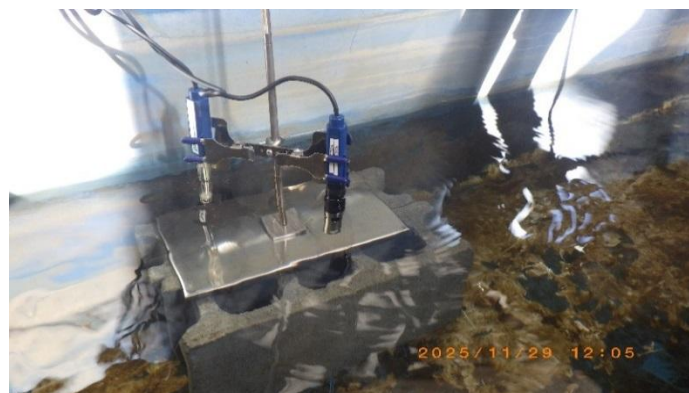
Photo 3. Installation position for pH and DO measurements in sharp-edged weir

For the September experiment, water samples were collected and analyzed for 35 water quality parameters, including pH and DO, at three points: before installing oxidized slag in the channel, several days after installation, and at the experiment's end. For the November experiment, a TOADKK DM-32P (see Photo 3) was installed within the blade-shaped weir at the channel's downstream end to measure pH and DO over time.

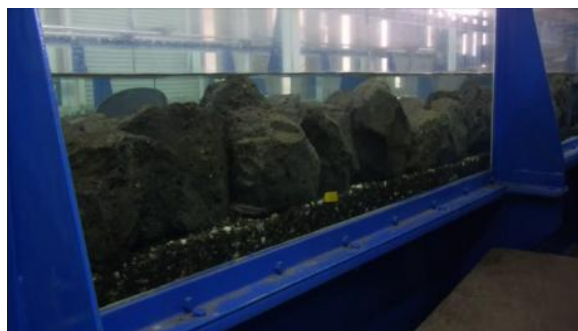
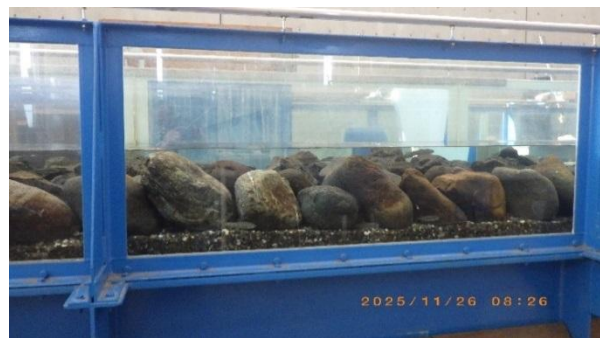
Photo 4. Flow conditions in consecutively assembled boulders

a) Flow condition at slag boulders side

b) Flow condition at natural boulders side

Photo 4 shows the flow condition passing through the consecutively assembled boulders due to oxidized slag and natural stones. As shown in Photo 4, the water surface exhibits a gradually varying flow profile (H1 curve), with almost no discernible surface irregularities. Furthermore, the flow within the gaps of the assembled boulders is reduced, preventing the scouring of pebbles beneath the assembled boulders and the displacement of aquatic animals.

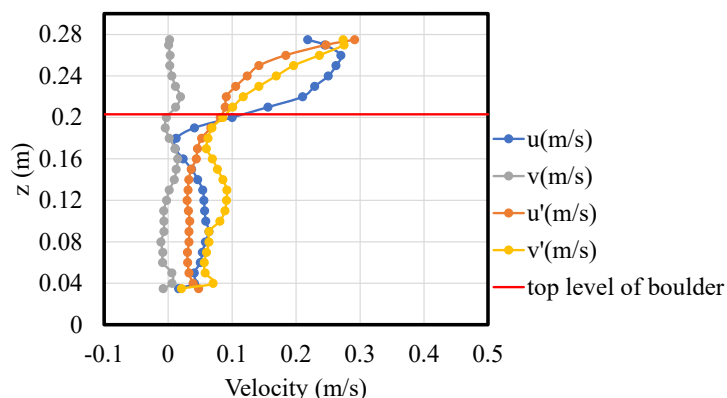
Figure 6. Velocity Distribution in assembled boulders ($x=3.5\text{m}$, $y=0.16\text{m}$)

Figure 6 shows an example of the flow velocity distribution in the installation region of assembled boulders. In this figure, u and v represent the time-averaged flow velocities in the x and y directions, respectively, while u' and v' represent the standard deviations (turbulence intensity) of the flow velocities in the x and y directions. The red solid line indicates the crest line of the stone structure. Photo 5 shows the measurement location. As shown in Figure 6, both the time-averaged velocity and standard deviation within the stone structure are small. This suggests the flow condition is suitable for resting space inside boulders for aquatic animals. Furthermore, as the flow between boulders becomes seepage flow, even if the discharge increases, the flow between boulders is reduced, making it suitable as a resting environment. Generally, studies on the flow conditions during flood stages are conducted by changing the model scale. However, the flow inside boulders depends on the configuration of the assembled boulders, the spatial shape, and the spatial volume, making it difficult to explain solely by the effects of simple gravity and viscosity. In the application for prototype, it has been verified that the assembled boulders themselves become a refuge environment in the Sanagouchi River located in Omura City, Nagasaki Prefecture, where the boulders were placed with an average size of 0.40 m (Yasuda, 2025; Yasuda, 2026).

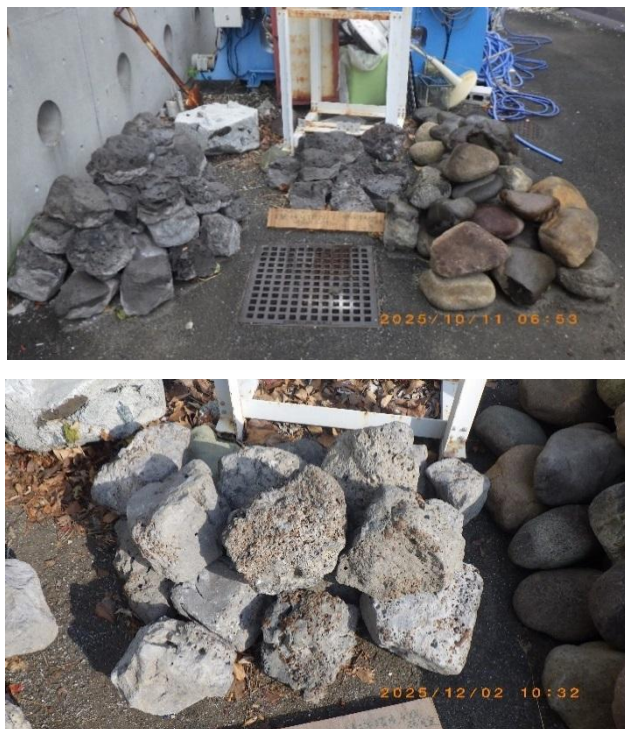
Photo 6. Condition of the oxidized slags one month after the first experiment in September

Photo 6 shows the state of the oxidized slag stored outdoors one month after the first experiment. Due to its outdoor placement, it has been repeatedly exposed to wet and dry conditions from rainfall. As shown in Photo 6, the difference from its state before the first experiment is minimal. After one month following the second experiment, slight rusting became visible. As a countermeasure, it is advisable to avoid oxidized slag where metal fragments are visible on the surface.

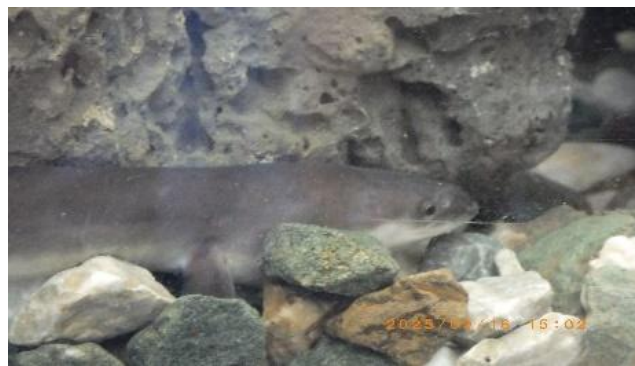
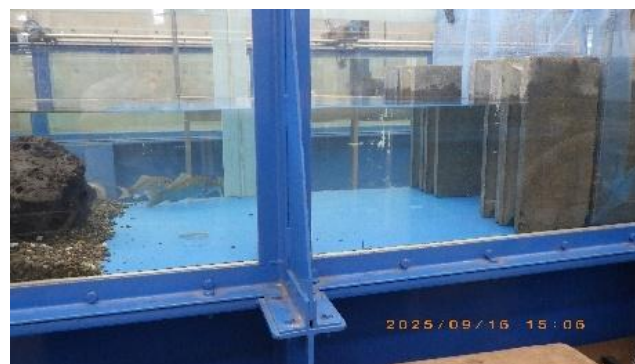
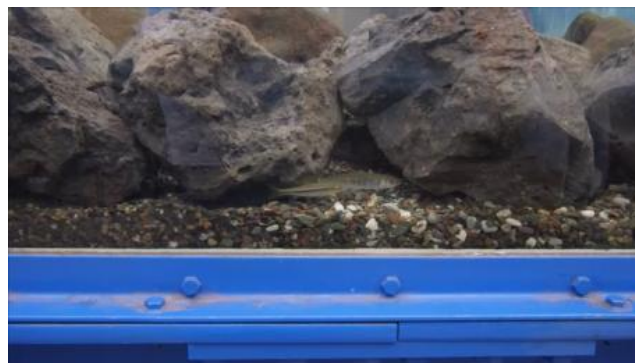
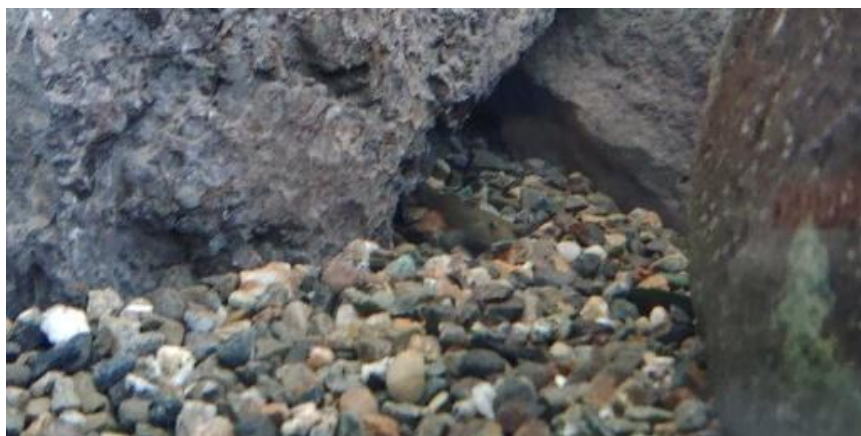
Photo 7. Aquatic animals observed in the installation of oxidized slag boulders

a) Eel inside oxidized slag boulders

b) Swimming fishes upstream of boulders

c) Swimming fishes in slag boulders

d) Amur goby inside oxidized slag

Photo 7 shows an example of recorded behavior of aquatic organisms released downstream of the assembled boulders in September. Regardless of the assembled boulders, the released aquatic animals utilize the flow between or over boulders to move. Eels hide in the gaps between boulders or among small pebbles during the day. Swimming fish, possibly wary of eels, positioned themselves upstream or downstream of the assembled boulders if less than 10 cm in length. When moving, they traveled through boulder gaps and over boulder surfaces. Freshwater shrimp positioned themselves in boulder gaps unaffected by the current and moved occasionally (Photo 7). Swimming fish around 20 cm in length move through boulder gaps and areas around the assembled boulders. When swimming fish near the assembled boulders sense human presence and retreat, they move toward the natural boulder side rather than the slag side, subsequently also seeking refuge in the boulder on the slag side. This behavior is thought to result from the slag being placed on the passageway side, causing the fish to retreat upon sensing human presence. The impact of the slag's uneven surface appears minimal, as gobies, freshwater shrimp, and freshwater snail (*Semisulcospira libertina* (Kawanina)) to the slag's surface, crawl along it, or move by hooking their claws. Table 4 shows changes in population size before and after the September experiment for each aquatic

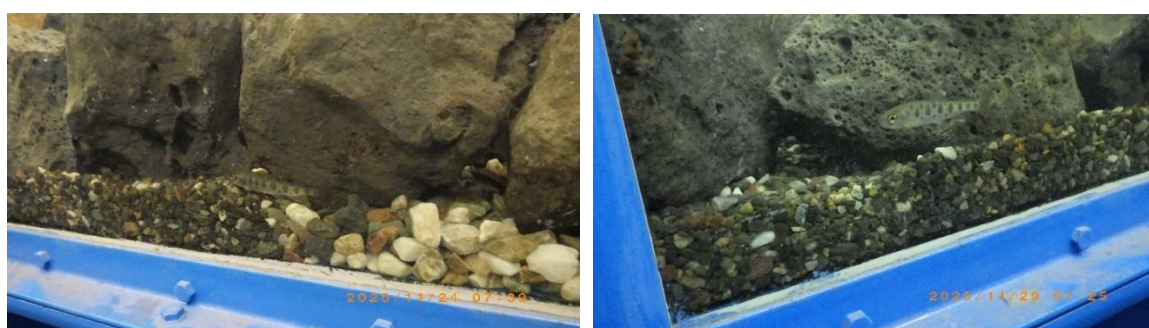
Photo 8. Yamame trout observed in the installation of oxidized slag boulders

Photo 8 shows one example of recorded behavior of aquatic organisms released downstream of the assembled boulders in November. At the start of the experiment, the released Yamame cautiously probed between gravels and showed no signs of actively entering the gaps. Subsequently, however, the released Yamame moved using either the gaps between stones or the flow over the gravel, regardless of the stone structure. That is, even when oxidized slag was placed on the passage side, the Yamame remained in the gaps or beside the slag, moved around, or traveled over the top. Furthermore, when there was a sign of human movement in the passage, they tended to become wary and hide within the boulder gaps. Additionally, about 70% of the released fish were observed in the gravel gaps, with the rest mostly found upstream or downstream of the assembled boulders. After the November experiment, all Yamame trout were recovered without any illness or mortality.
